AIRWAY POCUS IN RESUSCITATION

1. Dr. Himanshu Gul Mirani, Specialty Doctor, EM, QMC
2. Dr. Andrew Lindsay, Consultant EM, QMC

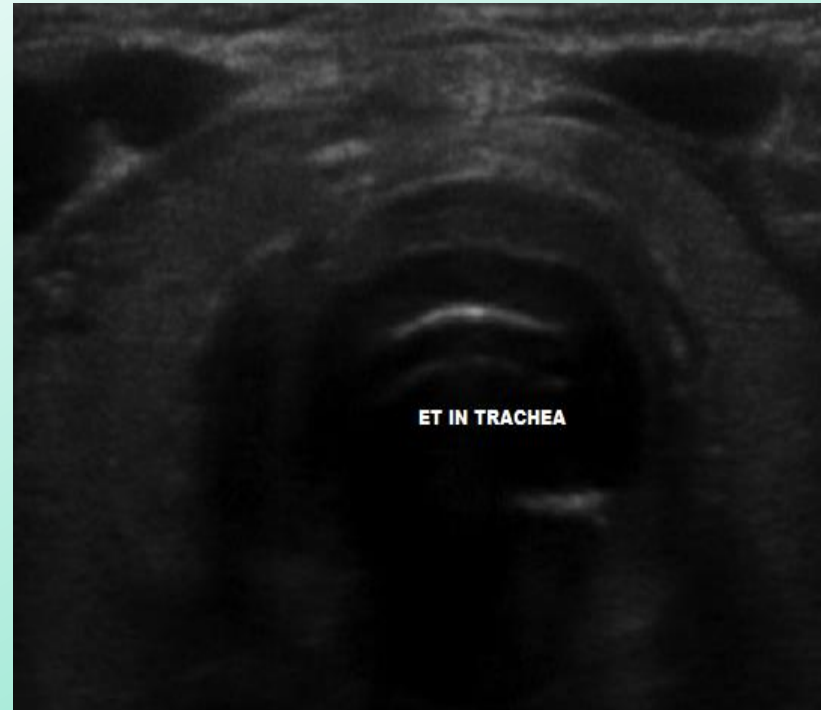
A point of care ultrasound (POCUS) of neck to show tube placement was done by the ED registrar who confirmed the ET was indeed in trachea.

Bedside ultrasonography of the neck to confirm ET placement can be particularly useful in case of equipment failure, as in the case above; or

Inflating the cuff with saline instead of air can help with easier detection of placement from the instilled water and bubbles.
